Project name: Dry Tortugas Pier Repair
Customer: National Park Services
Prime Contractor: CincoVega, Inc.
Subcontractor: Underwater Mechanix, LLC.

Location: Dry Tortugas, FL
Period of Performance: April 16th, 2018 – June 7th, 2018

Scope of Work consisted in reinforcing deteriorating concrete dock piles under Garden Key Main Government Dock and access ramps. Piles were encapsulated in a fiberglass jacket with concrete poured within to strengthen pile load-bearing capability. Also, seven (7) pile dolphin with similar wood structure were replaced.

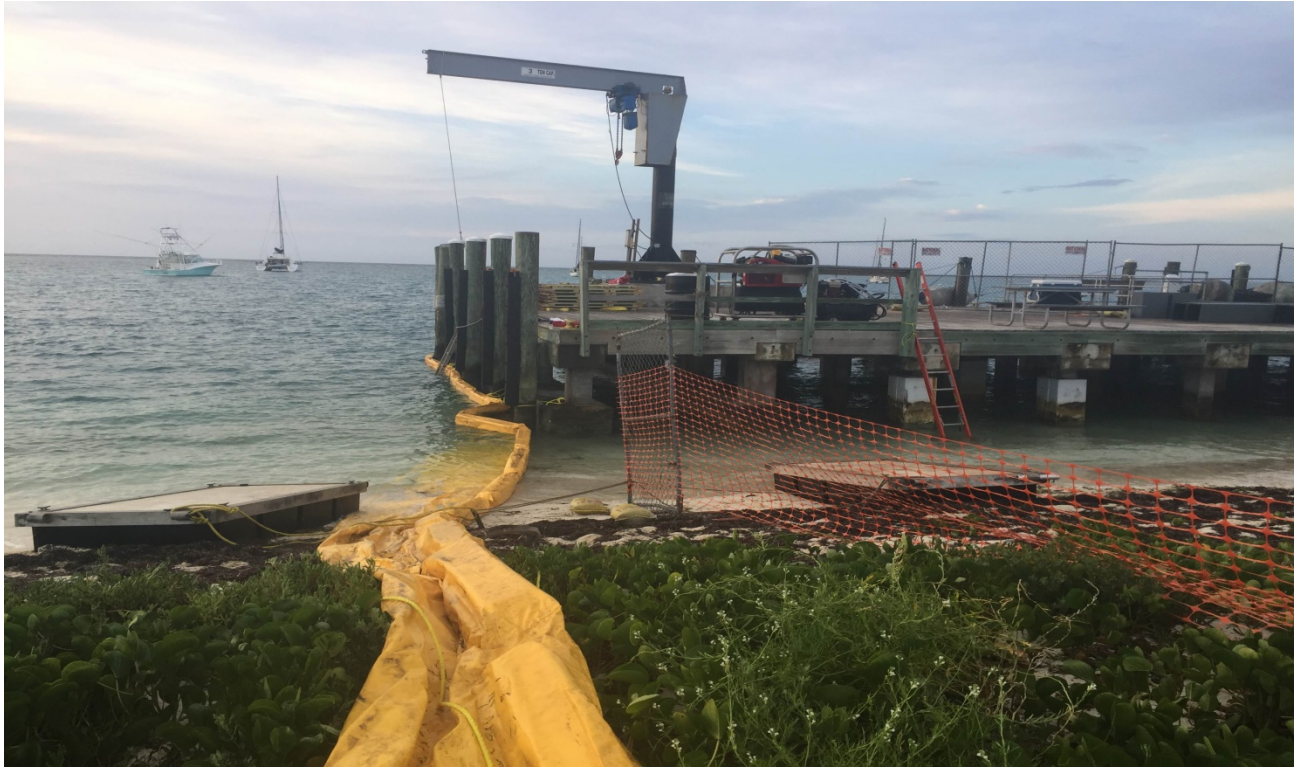
Equipment Set Up for Removal of Wood Piles

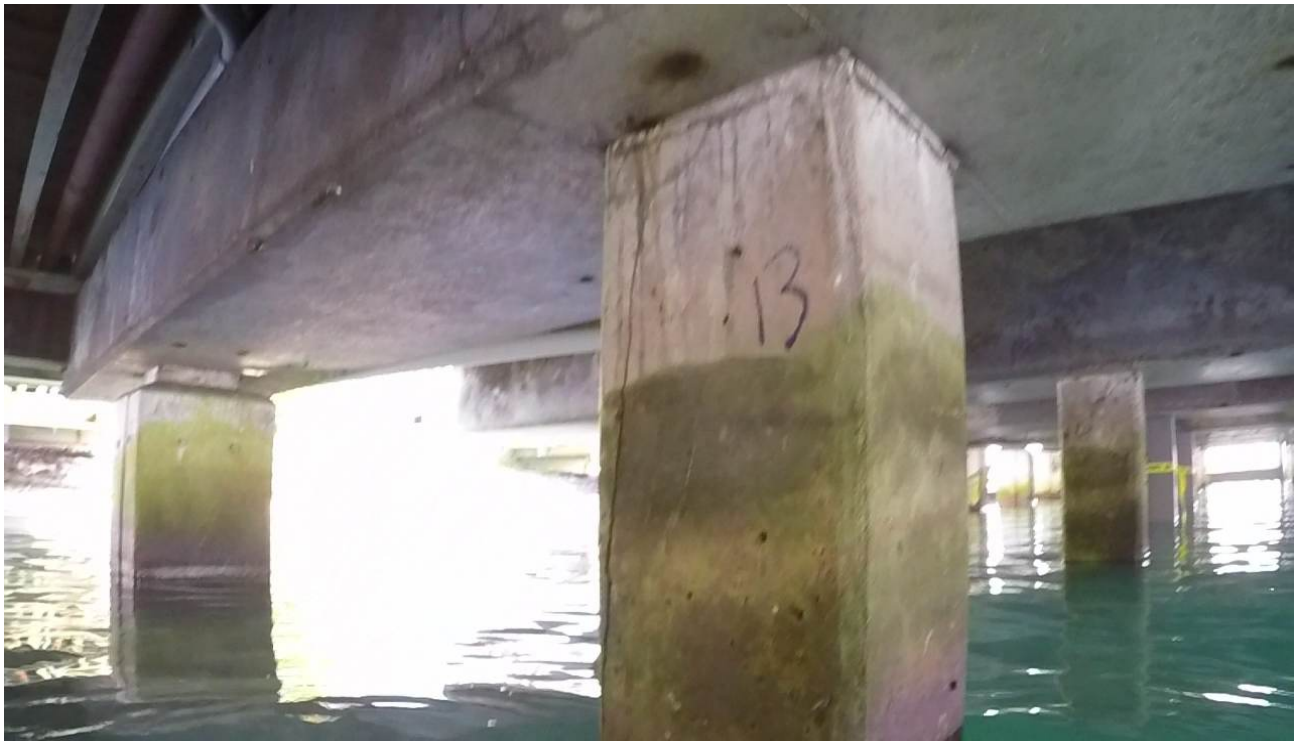
Concrete Dock Piles Sign of Deterioration

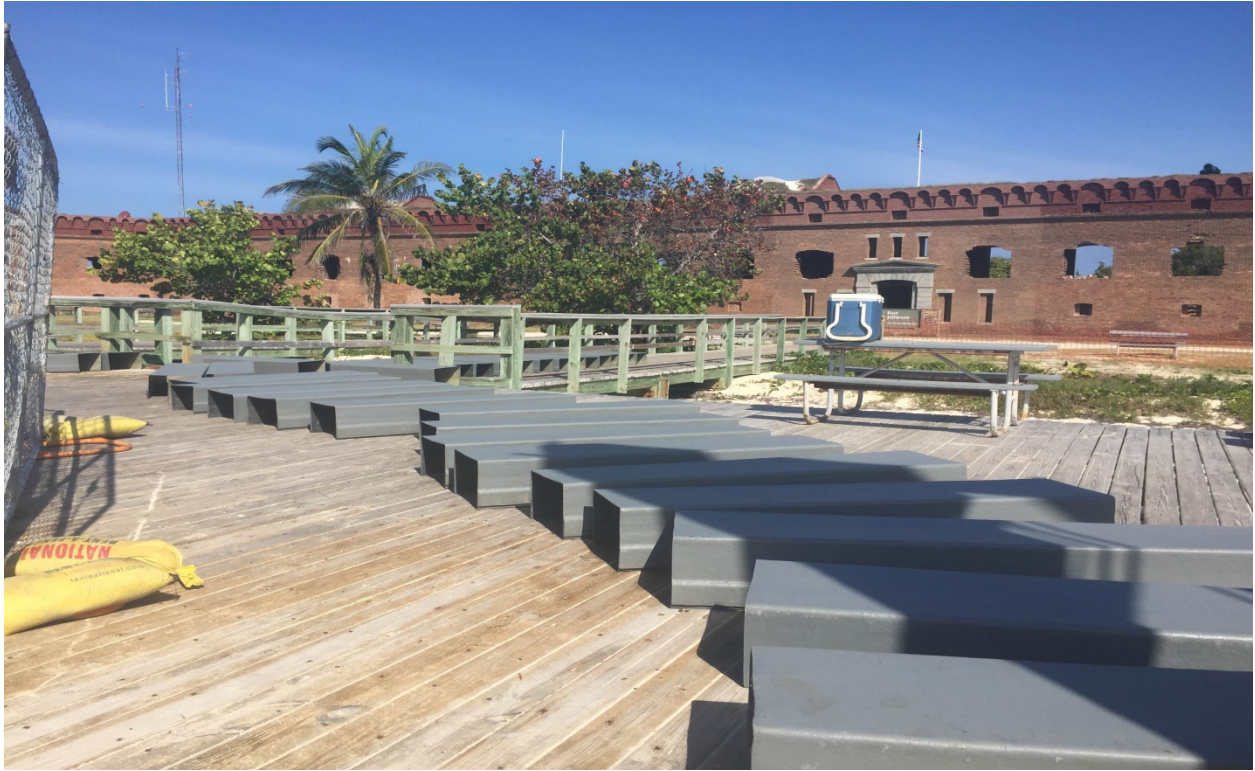
Fiber Glass Encapsulation Jackets Used for Concrete Piles' Reinforcement

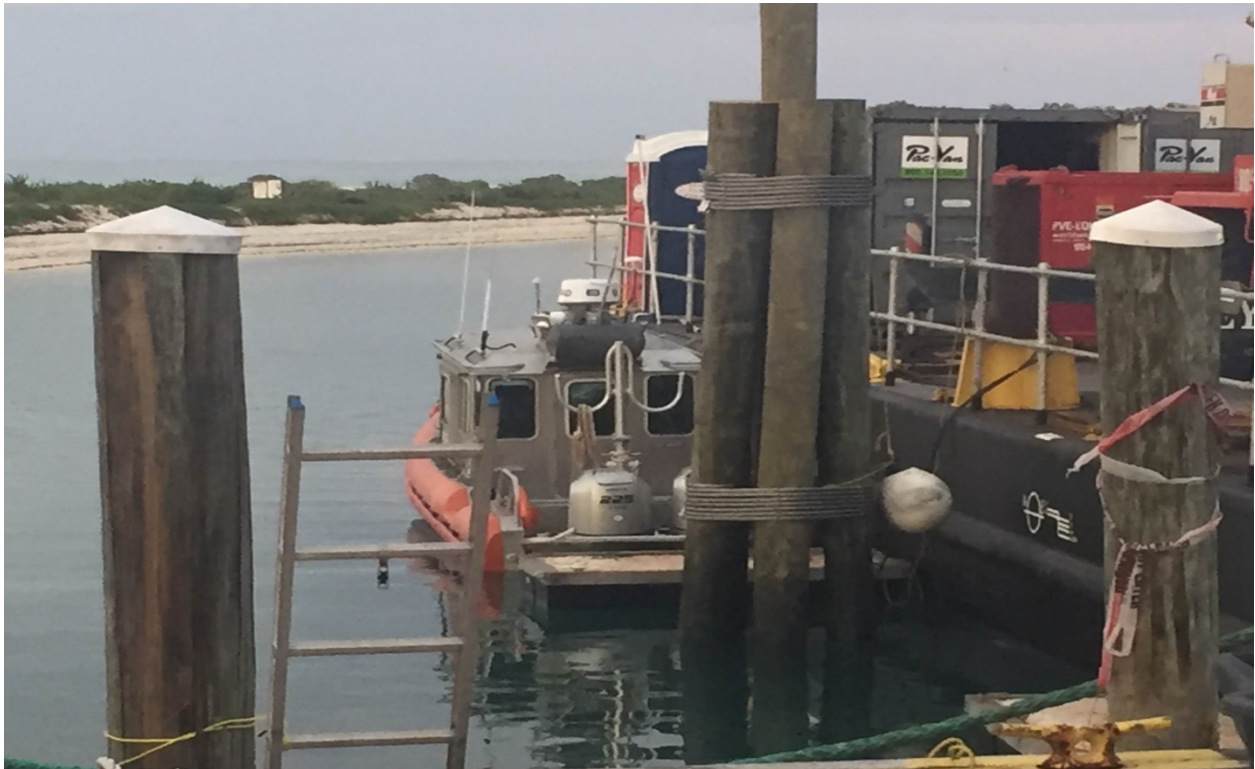
Removal of Wood Piles in Progress

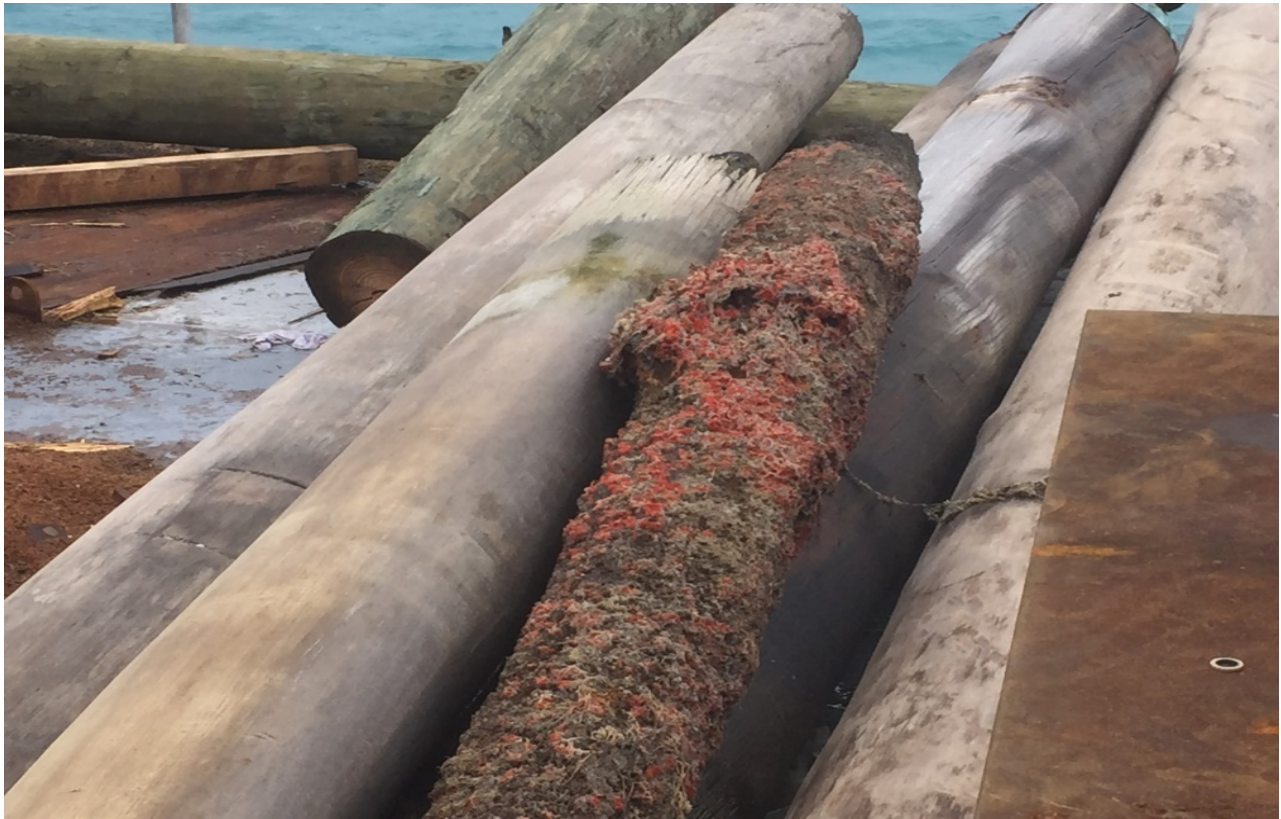
Completed Wood Piles Removal

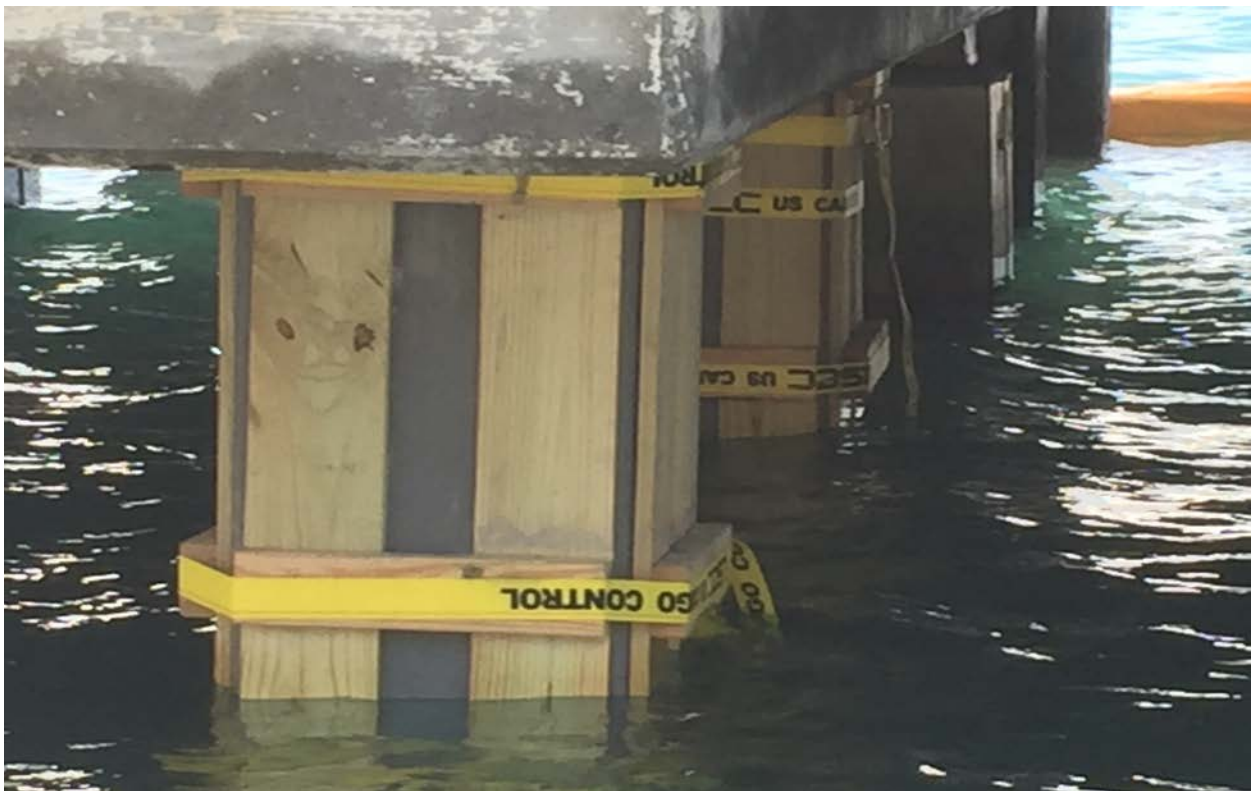
Reinforcement of Concrete Piles WIP

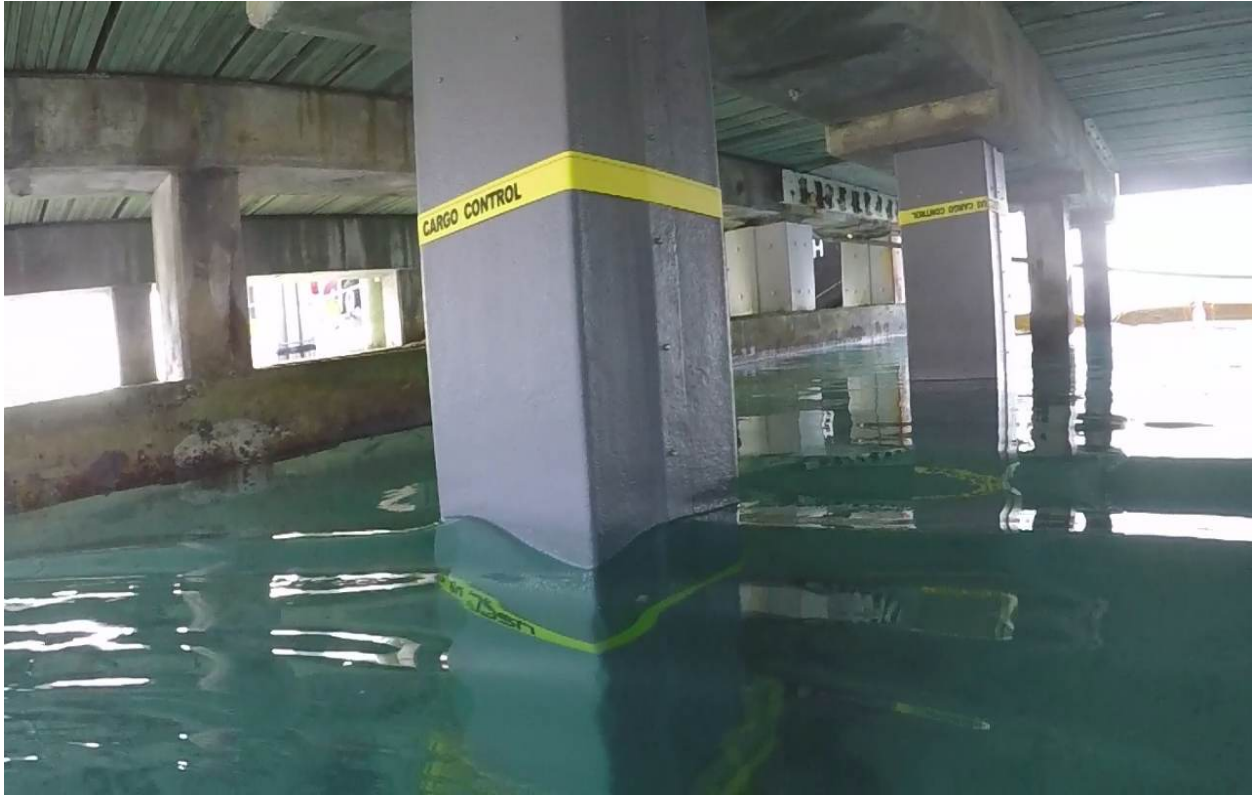
Completed Reinforcement of Concrete Piles
